# Madison's Lake Beaches

## Results of a Three-Year Pilot Study

### Using floating booms to prevent blue-green algal scums and debris from fouling Madison's lake beaches

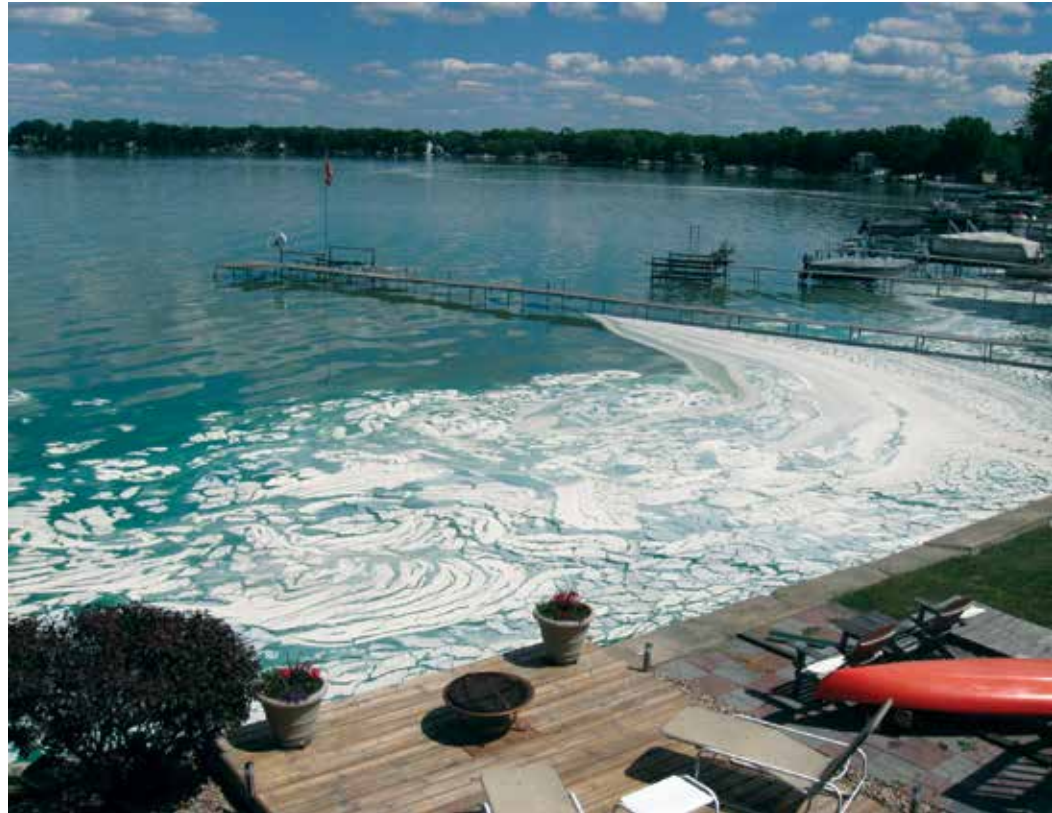
Figure 1. Blue-green algal scum on the Yahara lakes (Lake Kegonsa, June 6, 2012) (photo: Dane County Land and Water Resources Dept.).

Excessive growths or “blooms” of blue-green algae (cyanobacteria) commonly occur during the summer months (Figure 1) in the nutrient-rich Yahara lakes (Mendota, Monona, Waubesa, and Kegonsa) near Madison, Wisconsin. Such blooms are a serious health concern to humans and wildlife because certain species of blue-green algae can produce hepatotoxins, neurotoxins, and/or skin toxins leading to symptoms such as: liver and kidney lesions; and gastrointestinal, muscular, and respiratory symptoms including seizures and respiratory arrest. Although algal blooms often form throughout the lakes' upper well-mixed waters, some species of blue-green algae have gas vacuoles that cause the algae to rise towards the water surface when winds are relatively calm. Water currents from moderate winds then push the buoyant algae to downwind shorelines where the algae can pile up as thick mats or scums along with other floating debris such as cut aquatic plants (“weeds”), detached globs of filamentous algae, dead fish, and trash.

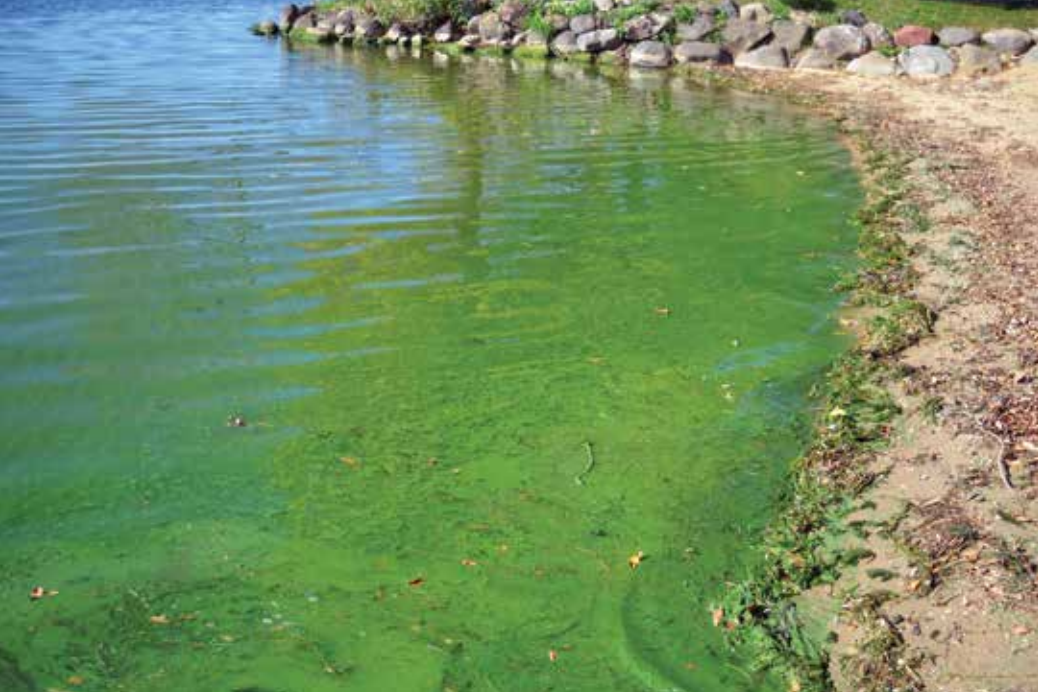
Figure 2. Algae pile-up in the protected shoreline cutout at B.B. Clarke Beach, Oct. 5, 2010 (photo: G. Steinhorst, City of Madison Engineering Dept.).

as tapered sand bottom cutouts into rip-rapped shorelines (Figure 2).

bloom occurred at B.B. Clarke Beach in late May prior to the deployment of the boom system and another algal bloom was present at the beach in early October after the boom system was removed (Figure 2). Microcystin toxin concentrations found in the fall bloom were greater than the highest measureable concentration ( $>125 \mu\text{g/L}$ ) for a sample taken of the scum itself, and  $8 \mu\text{g/L}$  for a sample taken below the scum layer. (For reference,  $20 \mu\text{g/L}$  is the threshold limit established by the World Health Organization for microcystin health advisories in recreational waters.)

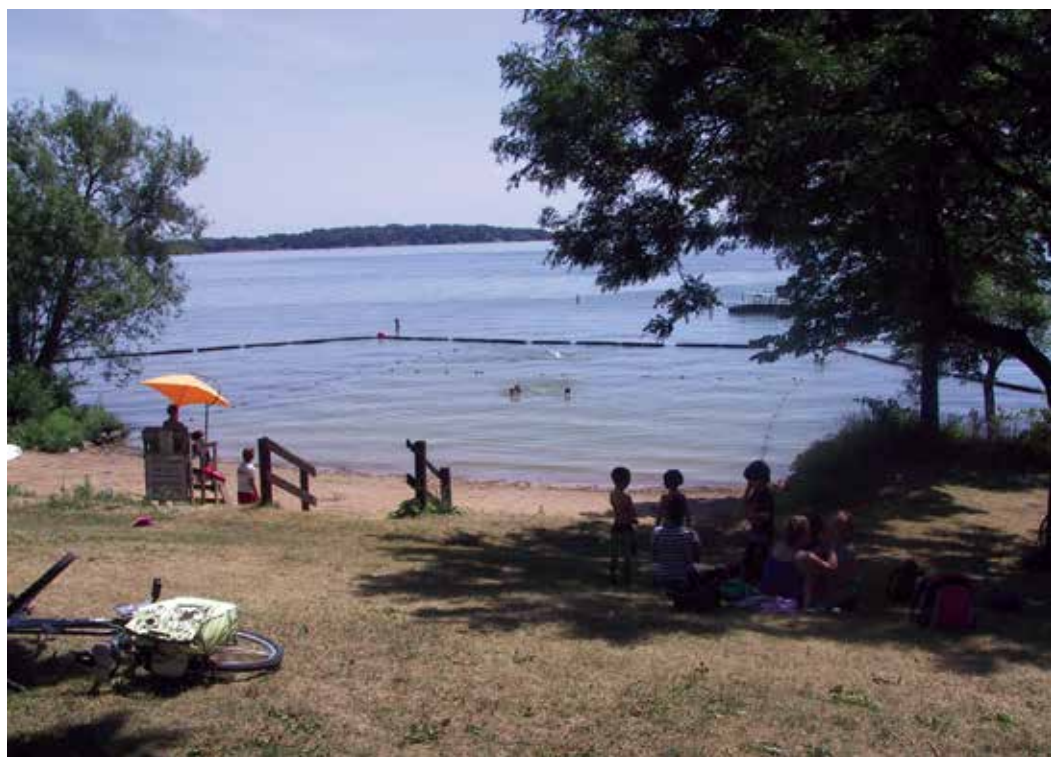
Figure 3. Three-sided, trapezoid-shaped deflector boom system deployed at B.B. Clarke Beach during June-August 2010-2012 (photo: R. Lathrop, WDNR).

of a trapezoid surrounding a beach’s swimming area (designated by floating ropes) with the much wider “base” of the trapezoid being the park shoreline extending beyond each side of the sand beach (Figure 3). Thus, the shorter endwall boom of the trapezoid was deployed parallel to shore just beyond

the roped swimming area. The two longer sidewall booms were designed to ideally attach at the park shoreline with an approximate 120-degree angle on the outside corner of the trapezoid. This design allowed the obtuse-angled sidewall boom when subjected to long-shore currents to “deflect” floating material away from the beaches and out into the lake. During other times, floating material could be temporarily trapped outside the boom near shore.

**B.B. Clarke Beach.** The three-sided deflector boom system worked well at B.B. Clarke Beach (Figures 3, 6) during all three summers of boom deployment in 2010-2012 because this beach is often exposed to long-shore water currents (Figure 7). Beach users and lifeguards during informal interviews felt the beach was much cleaner with high public acceptance of the boom system. However, in 2010 the popular diving platform was not installed in deeper water beyond the boom endwall due to concerns that lifeguards could not easily traverse the boom wall if an emergency occurred. Experience showed that the boom wall was not a barrier (even acting as a safety float) such that the diving platform was installed in subsequent summers.

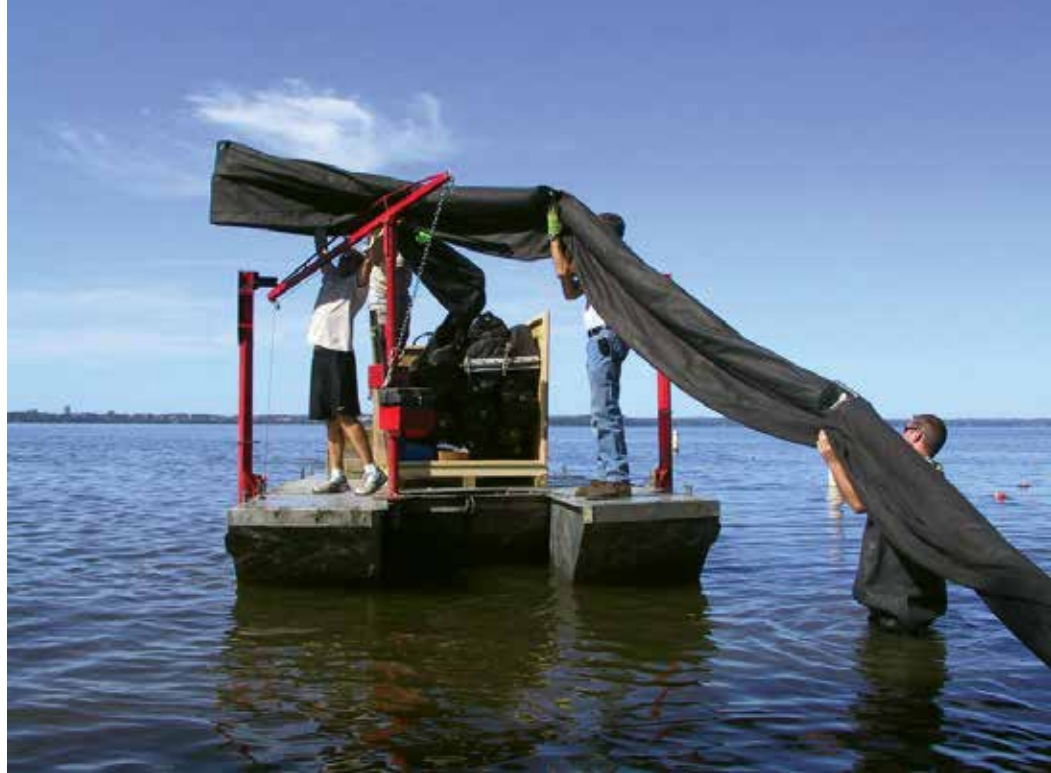
Figure 4. Boom wall being unloaded from a barge, June 2012 (photo: R. Lathrop, WDNR).

(6-inch diameter) covered by a double layer of fabric for extra durability (Figure 4). A hanging fabric curtain weighted with a ballast chain extended one foot below the floatation collar to ensure good interception of floating debris in the lake while allowing water to circulate freely underneath the boom. This design prevented water from stagnating within the swimming area. During windy periods with strong waves and water currents, the curtain was designed to “billow” sideways thereby reducing pressure on the boom wall. A stainless steel tension cable in the curtain directly underneath the floatation collar allowed each boom wall to be tightly stretched in a straight line between two anchoring points on the shoreline and/or in the water.

**Boom installation.** Deploying each boom system required a county barge and boat plus crew (Figure 4). After unfurling a boom wall from the barge, the shore end of each sidewall boom was attached by chain to a large tree, rip-rapped boulder, or iron tie-down rod on shore. In the lake, each sidewall boom was connected to the endwall boom by bolting the curtain edges together to form a tight seal at each corner. Then the two boom tension cable ends on the outside of each boom corner were attached to a large floatation barrel. Ropes attached to each corner barrel allowed the barge and boat to stretch the three-sided boom system to its full size. Heavy concrete anchors were then placed in deeper water some distance away from the corners in the general direction of a perpendicular bisector of each corner angle to equalize the tension on the two boom walls. Finally, the anchors were chained to each floatation barrel with full tension put on the boom system to make

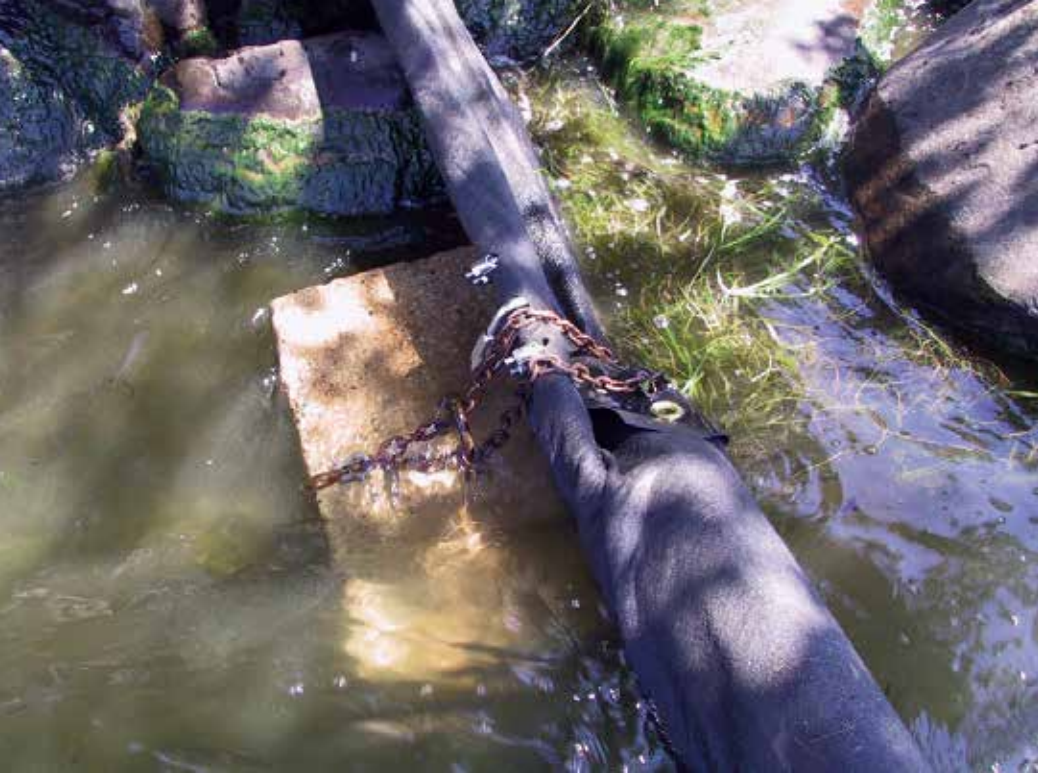
Figure 5. Concrete block and chain used to prevent boom wall from being lifted out of lake at shoreline (photo: R. Lathrop, WDNR).

Because the shoreline attachment point was usually well above the waterline, the boom wall tended to lift out of the lake near shore. That problem was rectified by placing a heavy block at the water's edge and chaining the boom's tension cable downward to the block at a point right next to the edge of the first floatation tube (Figure 5). A 5-ft piece of geotextile curtain fabricated on each sidewall boom's shore end helped ensure a tight seal at the shoreline to prevent floating debris from leaking into the swimming area.

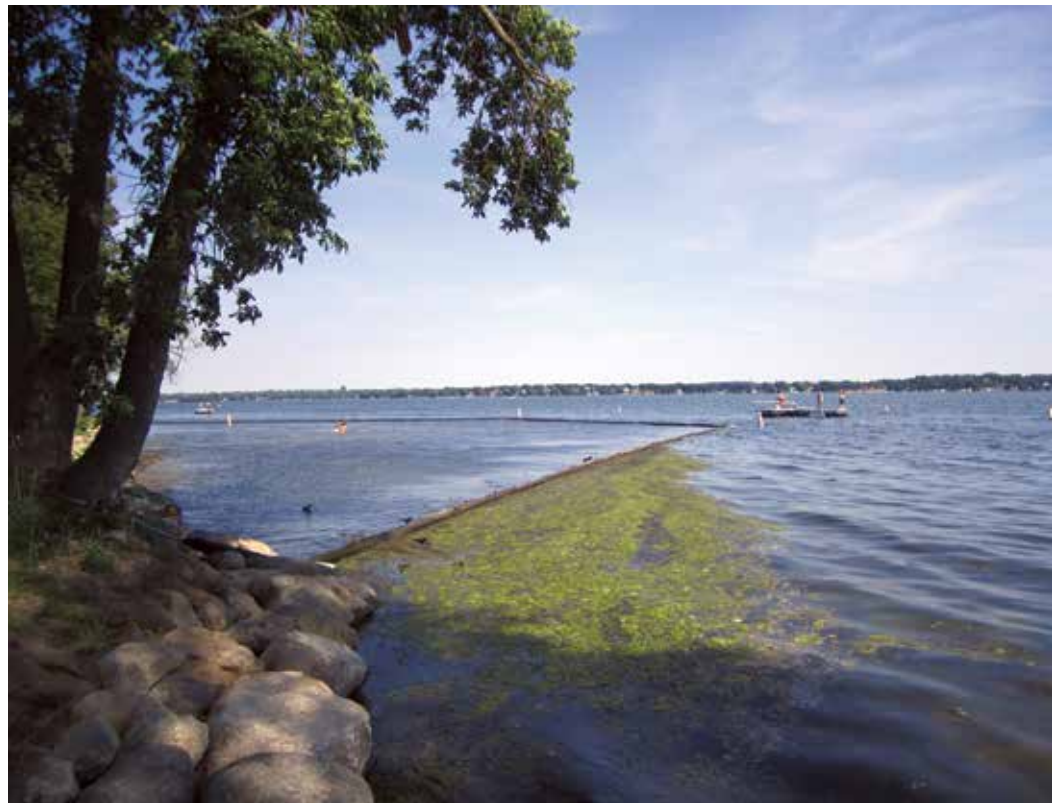
Figure 6. Photo showing the deflector boom system preventing algal scums and other floating debris from entering the enclosed swimming area at B.B. Clarke Beach, June 2012 (photo: C. Betz).

In addition to the water sampling results, a photo taken by a lake user in June 2012 showcased how the western sidewall boom prevented algal scums and other floating debris from entering the swimming area (Figure 6). The floating material was trapped in the southwest corner of the boom at shore. No health advisory was posted at the beach during this period and the trapped debris later left the area. In another example of how floating debris interacted with the boom wall, photos taken every five minutes for a period of 90 minutes during mid-July 2010 showed a mass of floating aquatic plants moving along the sidewall boom to its end where the plant mass was released into deeper water.

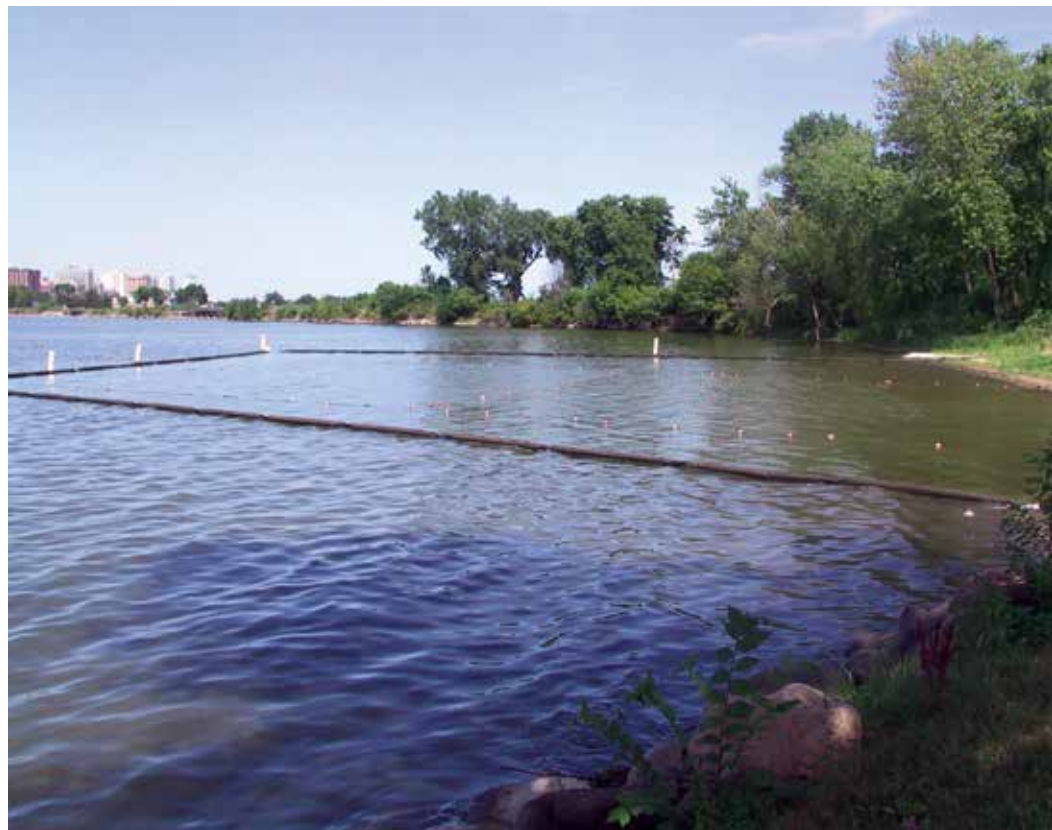
Figure 8. Deflector boom system deployed at Bernie’s Beach, June-August 2010-2011 (photo: R. Lathrop, WDNR).

**Bernie’s Beach.** The deflector boom system deployed at Bernie’s Beach (Figure 8) during the summers of 2010-2011 maintained the swimming area free of algal scums and other floating debris. Because of the more sheltered and restricted location of the beach area in the corner of Monona Bay, the two sidewall

booms were attached to shore with outside wall angles only slightly greater than 90 degrees. Floating material was often observed trapped outside the corner of the west sidewall boom (Figure 9).

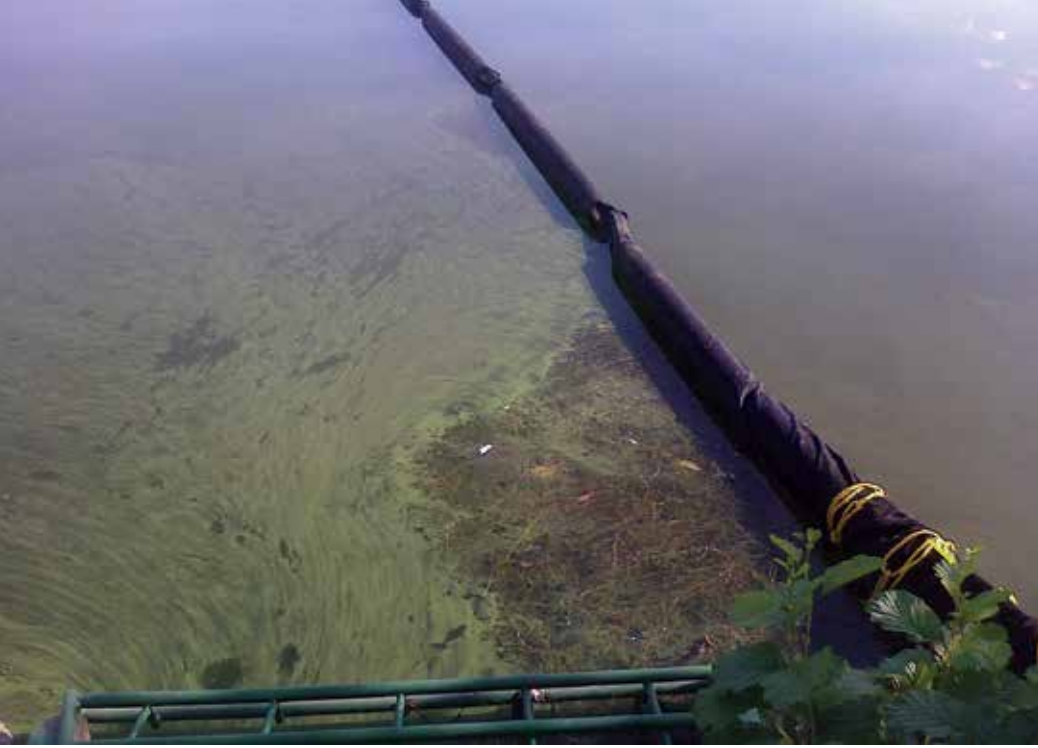
Figure 9. Algae scum and other floating debris trapped outside the sidewall boom at Bernie's Beach, July 2010 (photo: G. Steinhorst, City of Madison Engineering Dept.).

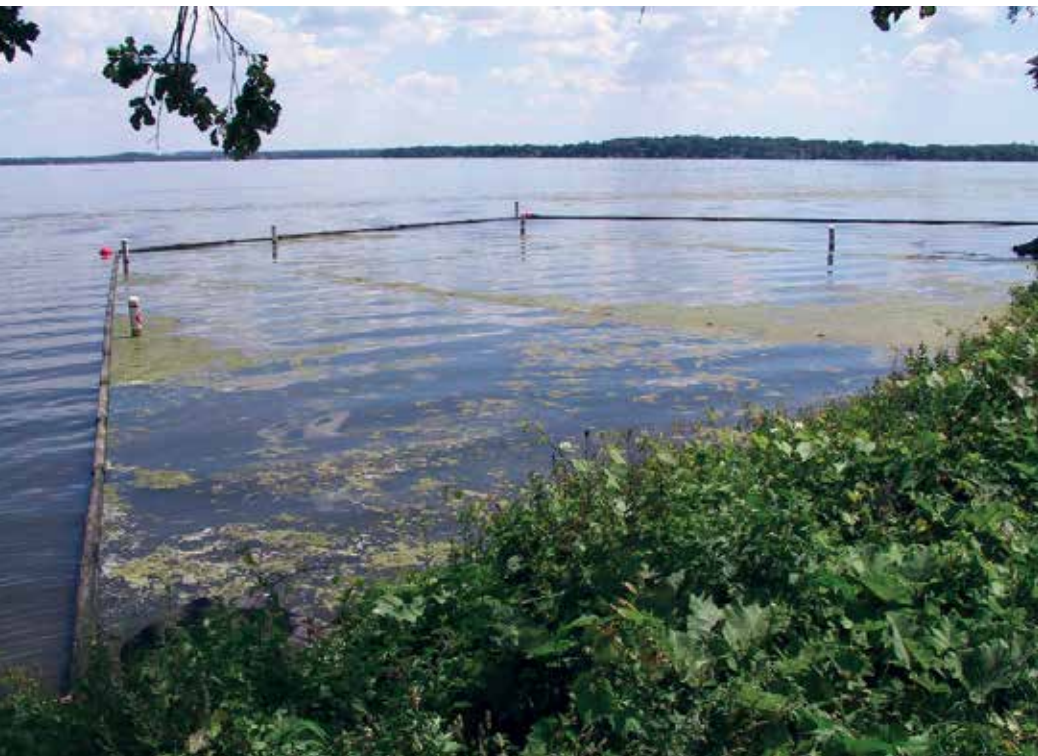
Figure 10. Deflector boom system deployed at Olin Beach in 2012 showing aquatic plants and filamentous algae growing inside and outside the boom system (photo: R. Lathrop, WDNR).

**Olin Beach.** The deflector boom system tested at Olin Beach on Monona’s southern shoreline in 2012 did not work particularly well even though the boom system itself was a good fit for the beach (Figure 10). The main problem was the swimming area inside the boom system was very shallow with a significant amount of aquatic plants and filamentous algae growing from the lake bottom. This area was cleaned out with a weed

harvester prior to installing the boom, but the filamentous algae quickly grew back into thick masses that created unappealing swimming conditions. This southwest beach shoreline often was on the upwind end of the lake where water currents could

not remove the floating material trapped outside of the boom walls.

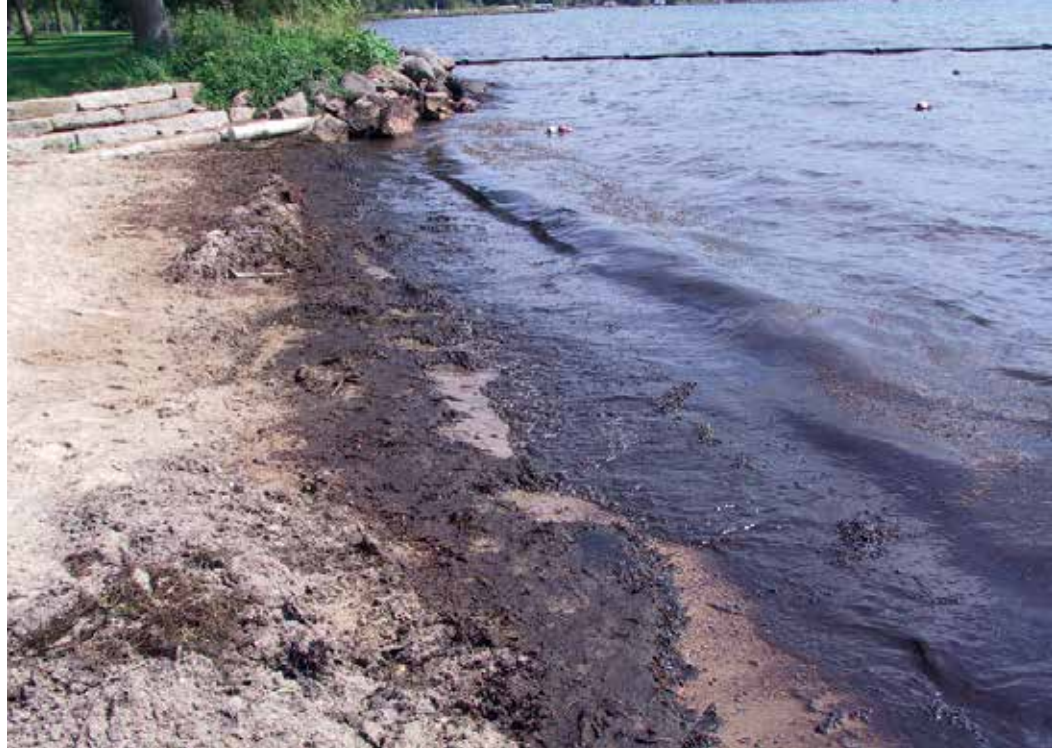
Figure 11. Suspended debris in the water and on shore inside the deflector boom system at Warner Beach in late July 2012 (photo: R. Lathrop, WDNR).

different from the other beaches tested. First, during prevailing southwesterly winds, Warner Beach on Mendota's northeast end had a very long fetch (longest distance waves travel unobstructed) and hence was subjected to high waves and strong water currents. While blue-green algal scums were not a problem in Lake Mendota in summer 2012, decaying filamentous algae fragments originating from shallow areas all over the lake apparently had passed underneath the boom walls and became trapped as a thick brown mass of rotting sludge suspended near the beach shoreline (Figure 11).

If park personnel had the capability to suction out this suspended material, then the deflector boom system at Warner Beach could be beneficial. Otherwise, further testing is needed to determine if the deflector boom can help prevent blue-green algal scums from entering the Warner Beach area. Although this beach exhibited dense algal blooms in 2008 and 2009, water quality testing in 2012 showed only low algal densities and only trace levels of microcystin measured outside the boom during four sampling events and no toxins detected inside the boom.

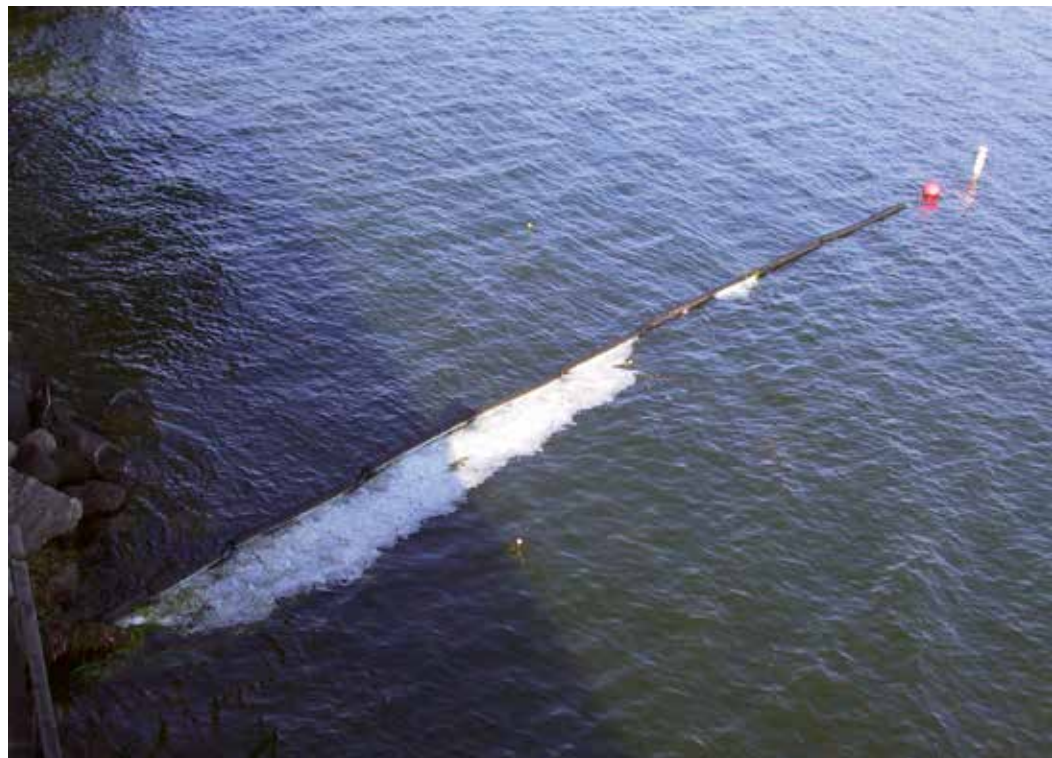
Figure 12. Floating material trapped on the single boom deployed at UW Center for Limnology in 2010 (photo: R. Lathrop, WDNR).

**Single boom test (UW-Madison shoreline).** The single boom tested at the UW Center for Limnology shoreline in 2010 was deployed with a 60-degree angle on the west side of the boom to trap material coming from that direction. However, floating material occasionally became trapped for short periods on the obtuse-angled side of the boom wall (Figure 12) due to prevailing winds that summer. While large scums did not occur in 2010, this test demonstrated that a single boom could intercept and temporarily trap floating material.
